TROUBLESHOOTING YOUR RIFLE and SHOTGUN

By J. B. Wood

**Do-it-Yourself
Diagnosis and Repair
for Rifles and Shotguns**

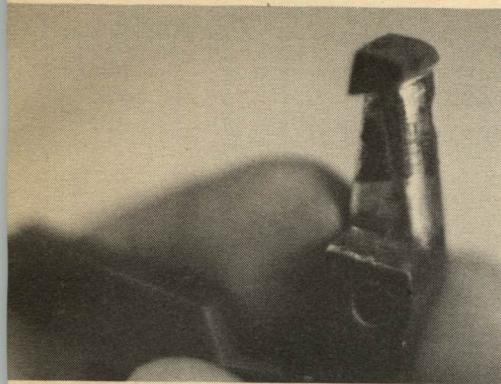
On the postwar Charles Daly, the only repeated breakage I have observed is the upper arm of the hammer cocking lever. The one shown here has been repaired by welding, and is not yet fully reshaped or rehardened.

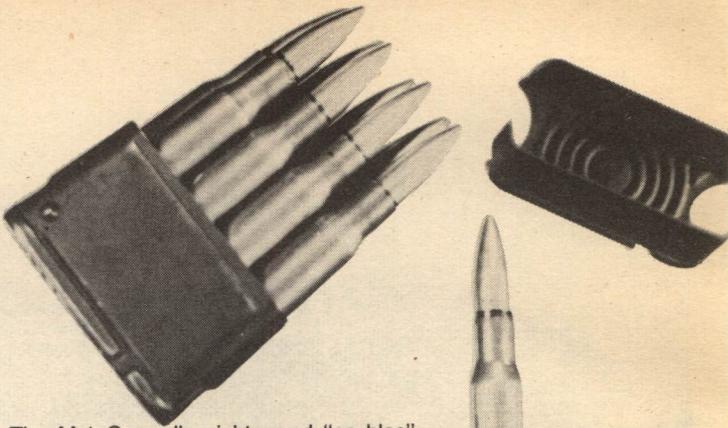
The weakest point in the design is the magazine system. The charger-clip loading limits the capacity to eight rounds, and reloading a partially-emptied magazine is not possible unless the clip is ejected and manually refilled—a tedious procedure. In hand-filling a clip, care must be taken that all rounds are seated fully to the rear of the clip, an endeavor that is unsuited to combat condi-

The M-1 Garand's eight-round "en bloc" clip at the left, an empty clip is shown on the right. When the ammo is expended, the clip is mechanically tossed free of the action allowing for the insertion of a fresh clip full of ammo. Reloading the en bloc clip, by hand, can be tricky; and, from a combat or even "sporting-use" point of view, reloading a partially-emptied clip is not feasible.

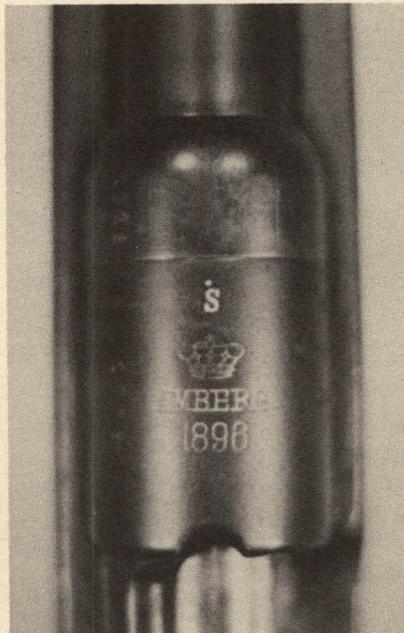
Receiver ring marking shows that this gun was made at Amberg Arsenal in 1896. Note the "S" above the crown, indicating that this gun was later altered to use the redesigned 8mm cartridge of 1905. In spite of the marking, these guns are only marginally safe with modern 8mm rounds.

you might need. Several of the surplus dealers are still selling some of these guns, and are advertising them as safe with present-day 8mm Mauser rounds, basing this on the "S" marking. Once again, shooting even the relatively mild U.S. commercial load in the Model 88 is risky. Feeding one of these a warmed-up 8mm handload could create some interesting problems for your hospital.

If you want to safely shoot the Model 88, there are two ways: Either obtain the proper dies and carefully handload your cartridges down to the early pressure level, or have one of the custom loaders, such as Ballistek, make them for you. Otherwise, the Model 88 should be used as a conversation piece on the wall of your den.

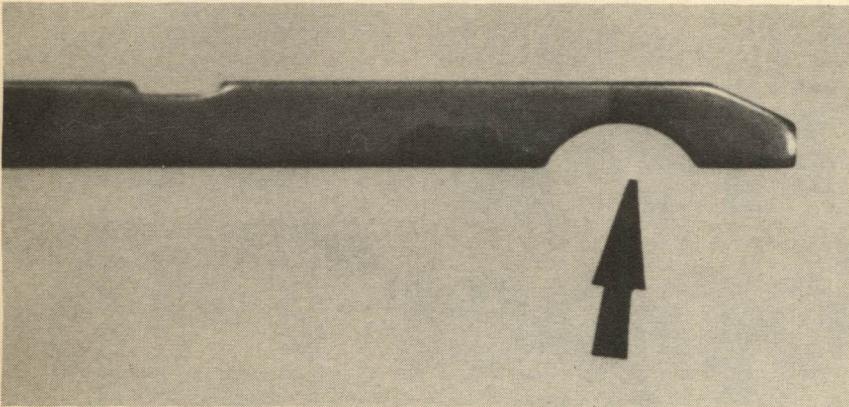
At the rear of the firing pin there is a semicircular cut to accommodate the bolt cocking handle. When the firing pin breaks, it is usually at this point.

The firing pin of the Model 760 has a deep semicircular cut at its rear to clear the bolt cocking handle, and the firing pin will occasionally break at this narrow point. The firing pin is stamped from flat steel, and I think that a few slipped into the production that were over-hardened, causing this breakage. It's not a common occurrence. If replacements are not readily available, making this firing pin is a simple matter for any good gunsmith.

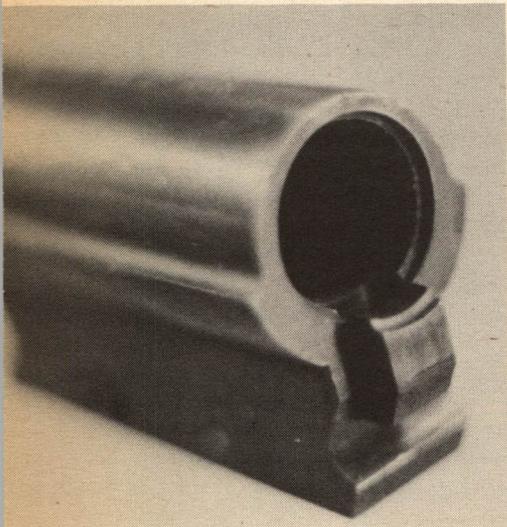
The Topper's ejector is a heavy, well-designed part—it rarely gives any trouble.

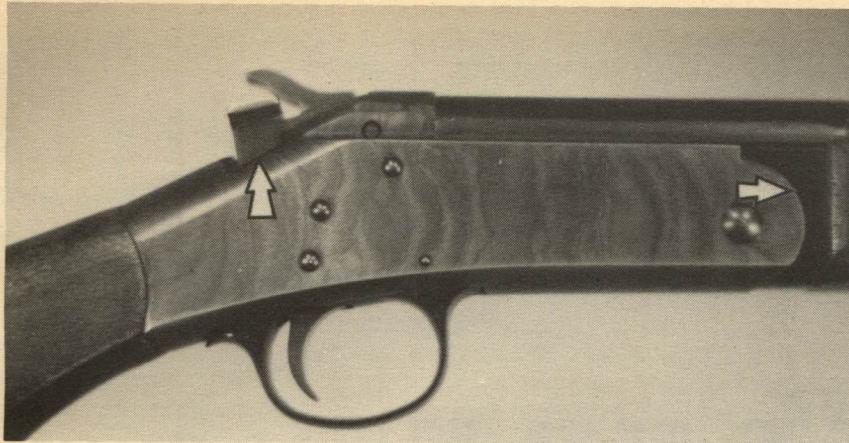
On late guns, the trigger guard and the spacer piece between the forend and the receiver are of plastic. The latter part is under no extreme stress, and the use of plastic material in this location causes no problem. The trigger guard, however, is subject to impact every so often, in normal use, and these do occasionally fracture. Replacement guards are not expensive, and all parts for the later guns are readily available. For the very early guns, some parts may have to be obtained from the used-parts dealers.

Left arrow points to the vertical barrel latch found on later models. The right arrow indicates the plastic fore-end base.

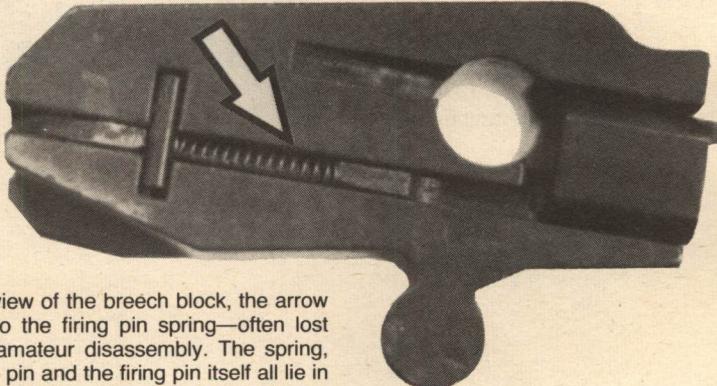
In this view of the breech block, the arrow points to the firing pin spring—often lost during amateur disassembly. The spring, its base pin and the firing pin itself all lie in recesses in the side of the breech block, retained only by the inside of the receiver.

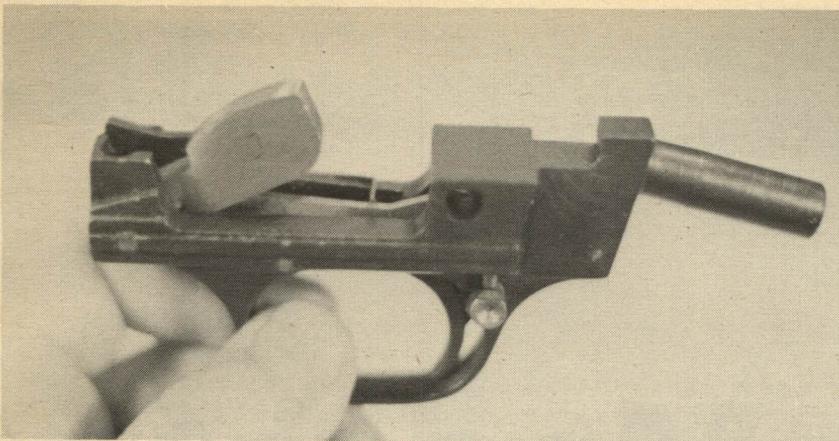
The all-steel trigger housing of the Model 37 is a masterpiece of good design—it won't give you any trouble.

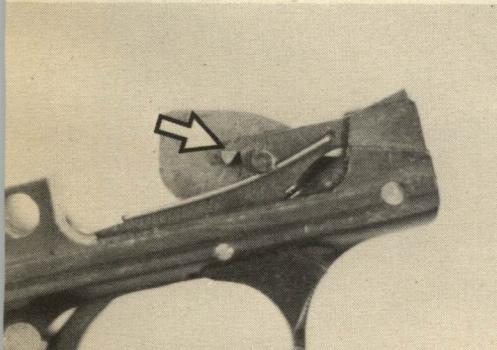
In older guns, there may be some wear at the engagement (arrow) of the hammer stud and the rear beak of the slide stop.

age weakening. In older guns, there may be some wear at the engagement of the stud on the right side of the hammer with the rear beak of the slide stop. If the wear is light, the parts can be recut to restore the proper meeting. If this is not possible, the hammer, slide stop, or both can be replaced—all parts are readily available.

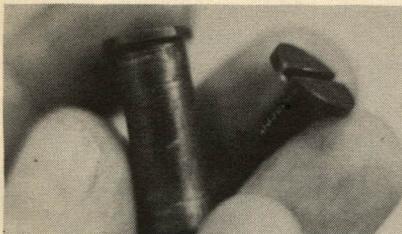
If the gun is taken down for transporting or storage, the barrel hinge pin and its retaining screw should be replaced in the receiver to prevent loss.

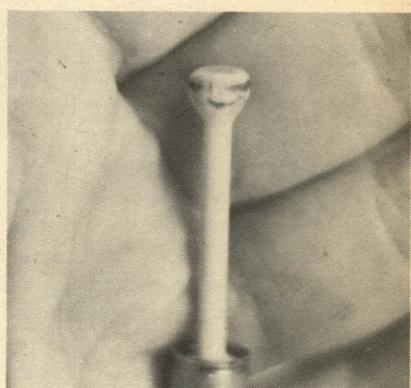
Like those on several other Marlin .22 rifles, the magazine follower is made of plastic and does not often break in normal operation. However, when the magazine tube is removed from the gun, careless handling can break or deform the follower. The rear sight is of similar design to the one used on the Marlin 336 rifle, with a folding leaf retained by lateral spring tension of the rear arms of the sight base. The sight elevator in its slot at the center tends to keep these arms from being compressed, but care should be taken in heavy brush, as a sharp blow can cause the leaf and elevator to depart, leaving the base on the barrel.

While it's not subject to breakage during normal operation, the plastic magazine follower can be damaged when it's out of the gun.

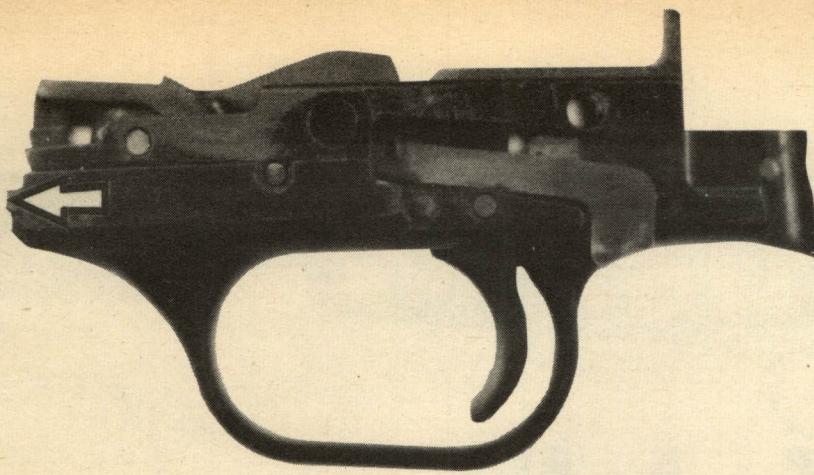
On later Mossberg 500s, the trigger housing is made of plastic—the forward retaining lugs (arrow) occasionally shear off.

rear by a large cross-pin. At the front, a small lug on each side mates with a recess inside the receiver. After long use, these have been known to shear off. To avoid replacing the entire housing, it is possible to drill an angled hole at each forward corner and install steel pins to replace the broken retaining lugs. In time, though, the pins may loosen in the plastic. When this occurs, they can be fixed in place with epoxy glue. In the mechanism of the housing, there are seldom any problems. All of the parts are well-designed, and there are no inherent weak points that might cause trouble.

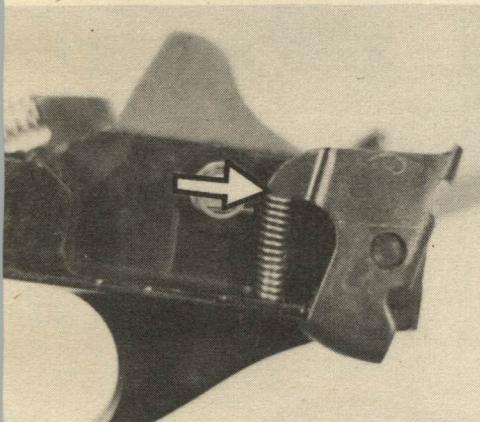
When the trigger housing is out of the gun, the magazine catch and its spring are easily detached, as they are retained on the pivot stud only by the inner wall of the receiver. When this happens, the catch will usually be found, but the little spring is under tension, and will often depart, never to be seen again. All parts are readily available, of course.

When the trigger housing is out of the gun, the magazine catch and its spring (arrow) are easily detached and lost.

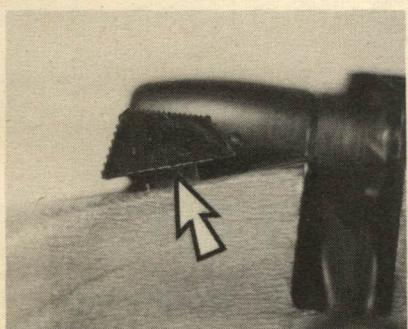
Another plastic part is the operating knob of the manual safety. When this is broken, the entire safety-lever must be replaced.

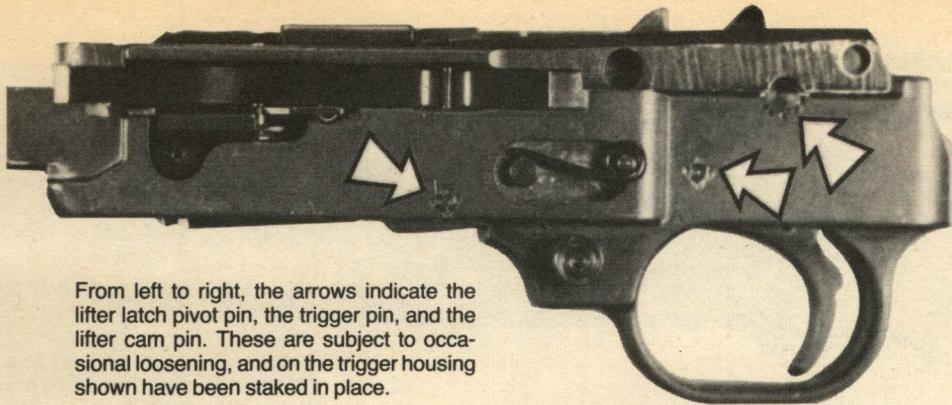
From left to right, the arrows indicate the lifter latch pivot pin, the trigger pin, and the lifter cam pin. These are subject to occasional loosening, and on the trigger housing shown have been staked in place.

certain parts because of the heavy recoil. In revolvers, the screws tend to back out, a condition often cured by a drop of Loctite. Later revolvers have nylon plugs set into the threads to prevent loosening. In the Ruger carbine, this same problem applies to several of the pivot pins. In the trigger housing, the ones usually affected are the lifter latch pivot pin, the trigger pin, and the lifter cam pin. The cure for this is simple and easy—just use a small punch to make stake marks beside each of the pins, on both sides of the housing.

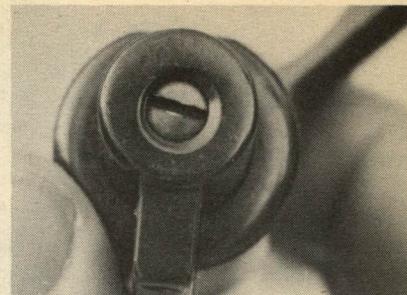
At the rear center of the cocking piece is what appears to be a screw, but this is definitely not the case. This is actually the rear tip of the firing pin, which is threaded into the cocking piece, and the screw slot simply allows adjustment of the protrusion of the firing pin point from the breech face. This adjustment is not the sort of thing that should be attempted by the amateur, as a miscalculation can

What appears to be a screw is actually the rear tip of the firing pin shaft. This should not be disturbed by the amateur.

cause either misfiring or pierced primers. For the benefit of any gunsmiths who might be reading this, the proper protrusion is .055-inch, and you'll need one of those neat little gauges that Brownells, Inc. sells for around \$10. On the underside of the cocking piece there is a small set-screw which locks the firing pin adjustment, and this one should be kept tight.

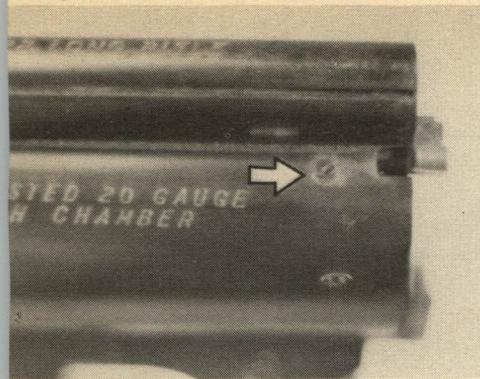
While the retaining screw for the .22 ejector (arrow) should be kept tight, it shouldn't be over-tightened—you can easily break it.

its shaft offset into the upper left quadrant of the lower barrel, and it is retained by a small headless screw which crosses a recess in the ejector shaft. This screw should be kept snug, of course, but beware of over-tightening, as the slotted top of the screw is easily split if too much force is used.

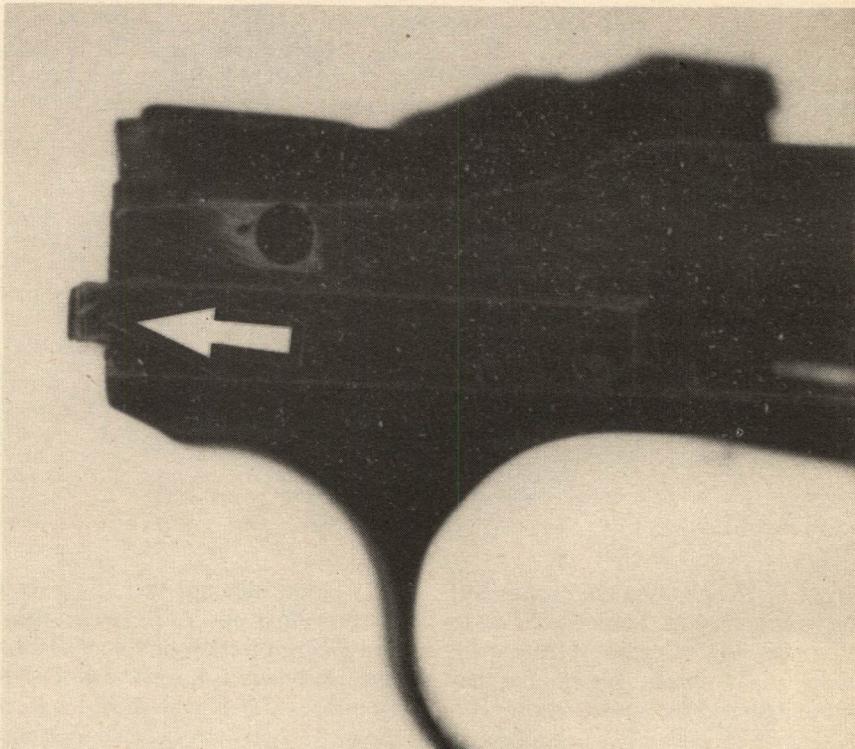
Arrow indicates one of the two opposing retaining lugs found on the forward portion of the trigger group. On the later alloy units, these tend to break off.

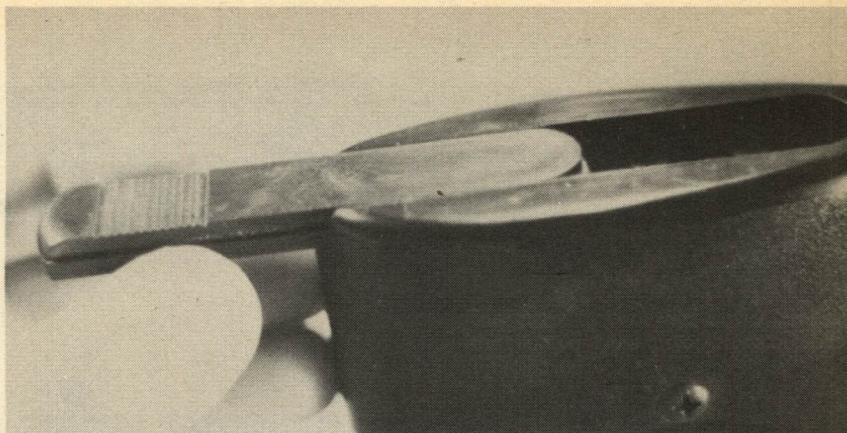
Opening the sliding trap in the buttstock (top) gives access to a storage compartment for four .410 shells. (Center) The hole at far left will accommodate a 3-inch shell, but the following three will hold only the 2½-inch version. (Below) While the sliding trap works nicely, it's locked only by a plastic nub—something a bit more positive is needed to prevent loss.

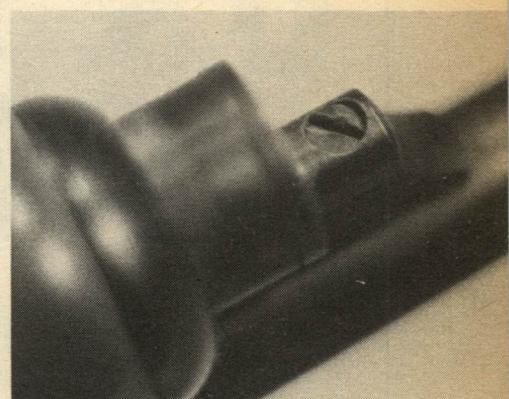
The large screw which holds the magazine tube endpiece beneath the barrel is prone to loosening—check it often.

In the same category is the large screw which secures the magazine tube endpiece to its mount below the barrel. In all three screw locations mentioned above, a drop of Loctite on the threads might prevent future difficulty.

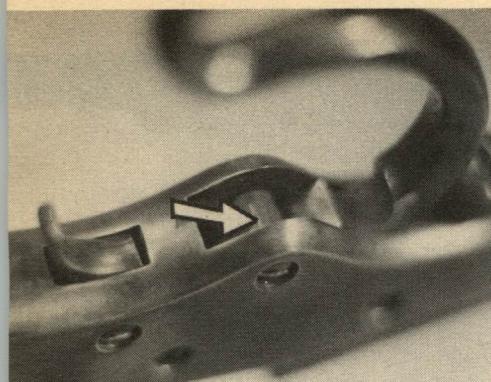
Arrow points to the lever lock roller, a part which is subject to considerable stress and wear.

ness. The screws and the link pin are not difficult to make, and the roller is no problem for any good gunsmith. Also, the used-parts dealers occasionally have some parts for these guns.

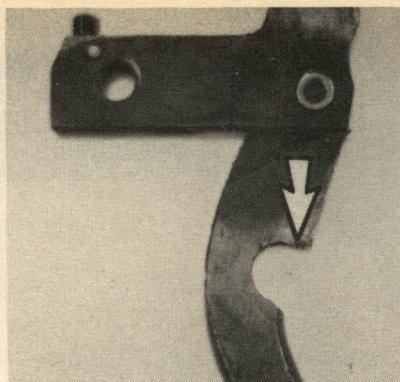
The arrow indicates the area on the lever which locks over the roller in the receiver, a point subject to wear.

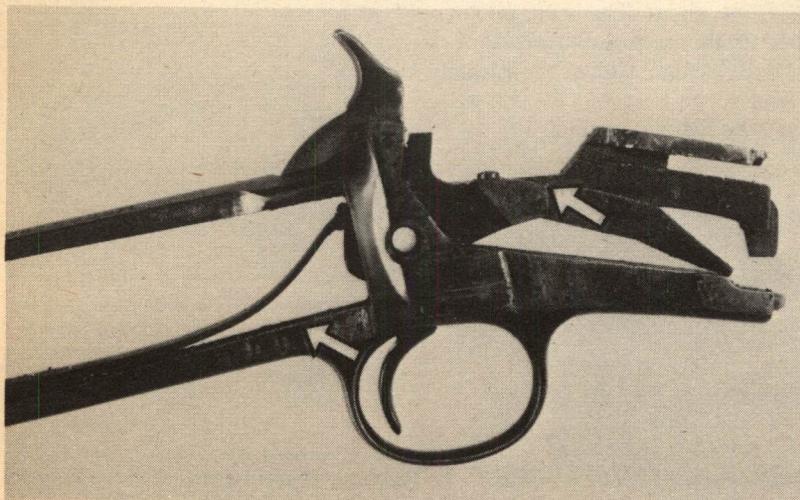
The arrow at the lower left of the picture below points toward the blade-type hammer spring which is severely flexed—it breaks with some frequency. The arrow at upper right indicates the location of the carrier spring, another blade-type spring which frequently breaks.

Like most of the early guns, the Model 90 is full of blade-type springs, and some of these are flexed rather severely. There are five main trouble spots: the hammer and trigger springs, the extractor, the carrier lever spring, and the breech block lock. The flat hammer spring breaks occasionally, the trigger spring less often. Replacement of either of these is not difficult, and original parts are usually available from the used-parts dealers. If these can't be found, either of these springs can be duplicated in doubled round wire (piano wire).

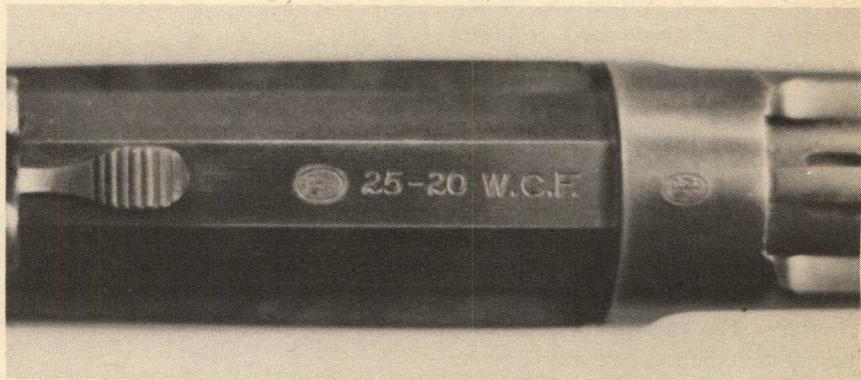
Caliber designation will usually be found clearly marked on top of the barrel, just forward of the receiver. The oval marks are the Winchester proof.

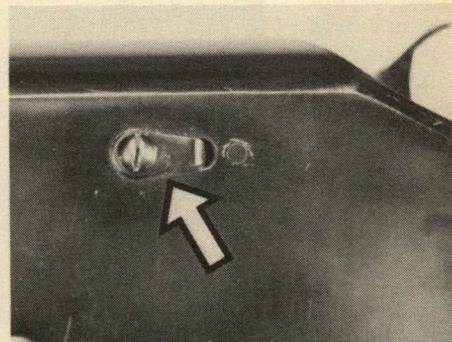
the shell rim each time the action is opened. It is backed up by a solid steel block, but breakage is common enough that it's a good idea to keep an extra one on hand. Two items of good news on this: First, the part has been reproduced in modern times and is readily available; second, the part can be replaced without stripping the gun since the ejector is retained by an external screw, its tip entering a hole in the receiver.

The Model 1897's ejector (arrow) is externally mounted on the left side of the receiver and is easy to replace.
